Biosecurity & Food Safety Compliance

Foodborne illness case study: Listeria monocytogenes in smallgoods

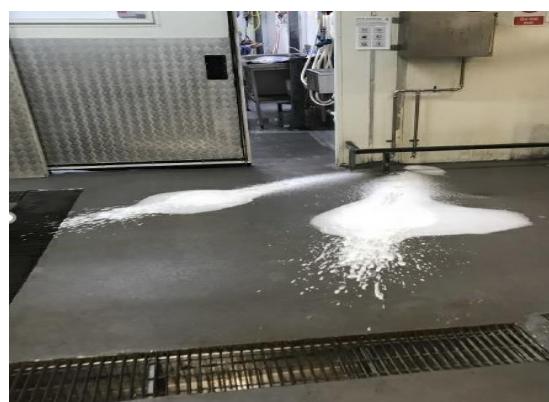
- A significant number of "small" maintenance issues such as damaged coving, small cracks in floors and wall and exposed wall insulation which can provide multiple harbourage points for listeria.
- Foot baths had been removed from the facility and replaced with a floor foaming unit. The floor foaming unit had not been verified as achieving a proven log reduction and appeared to not provide adequate coverage of the floor to be able to properly sanitise trolley wheels and boots in a corridor that was used for raw product, cooked product and movement of staff. (see photo A below)

Photo A: floor foamer

Facilities that are processing high risk RTE products need to be more aware of the post-cook contamination risk of *Listeria* and have processes in place to identify harbourage sites and potential sites for cross contamination. This includes “minor” maintenance issues such as cracks and crevices and “small” cleaning issues such as mould and mildew.

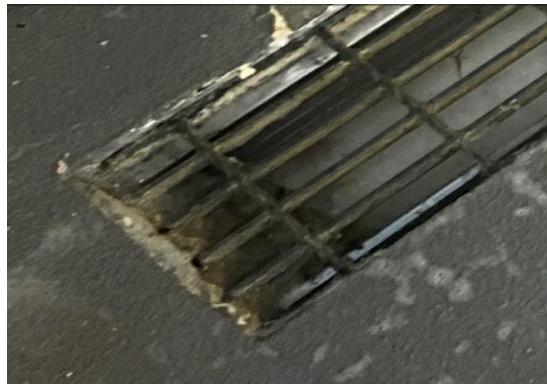
The grates on the trough drains were seized into place so proper cleaning of the

drains was difficult and had not been performed. *L. monocytogenes* was detected in the trough drains during the clearance process. (see photo B below)

Photo B: trough drain grates were seized in place

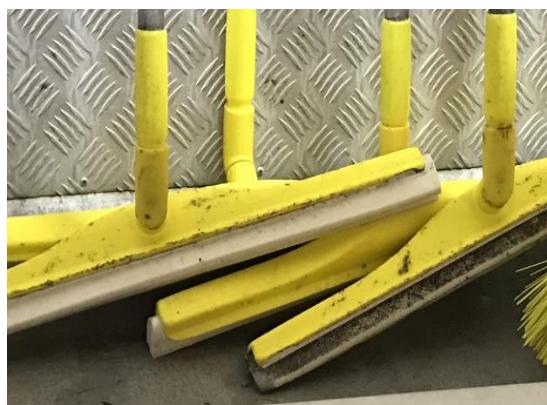
- A significant number of “small” cleaning issues indicate a larger problem with attention to detail with cleaning. E.g. floor squeegees that were damaged and unclean (*Photo C below*), mould growth around hand wash basin.

Photo C: floor squeegees damaged and unclean
